# Death in the line of duty...

A summary of a NIOSH fire fighter fatality investigation

September 16, 2005

## **One Probationary Career Firefighter Dies and Four Career Firefighters are Injured at a Two - Alarm Residential Structure Fire - Texas**

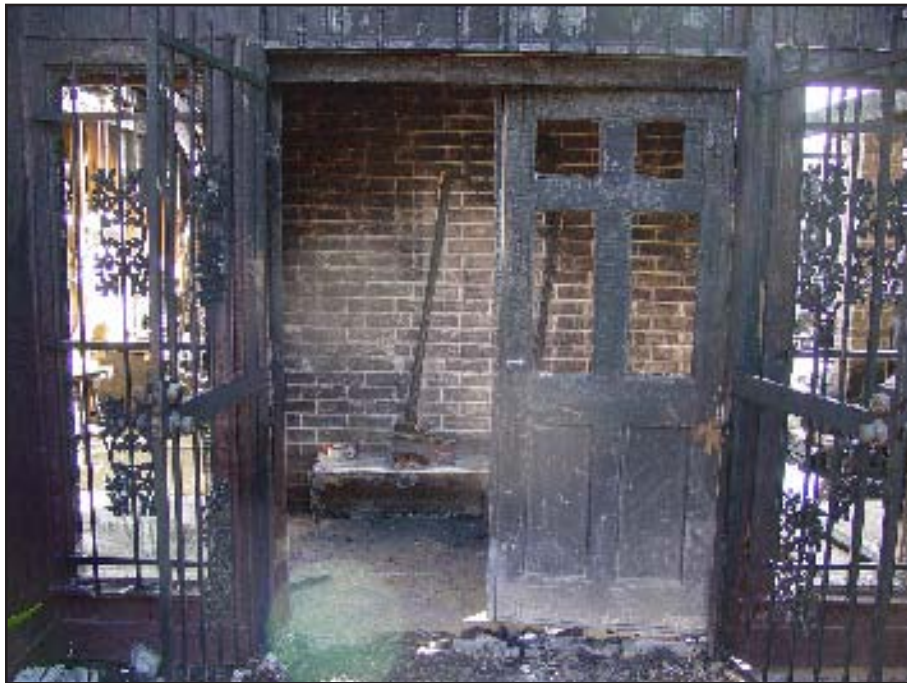
The crew from E-5 (staged at the front door, side-A) (Photo 1) stated that only minutes after entry was made, they heard muffled yelling and firefighters began crawling and running out of the structure. The E-5 crew began assisting the firefighters, as their gear was either smoking, or on fire. At this time, the E-3 (RIT) crew was approaching the front door. The time was approximately 1523 hours, less than four minutes after initial entry was made. The E-5 Lt. stated that he ran over to the IC command post and informed him that they had firefighters down, and to call for additional EMS units. The IC immediately called for a second alarm *(Note: the second alarm for this department is a single engine (E-4) and the dispatch of a volunteer fire department, which reportedly had an approximate 30-minute response time.)* The IC also called for additional EMS units (2 additional) and a PAR. E-2 reported that they had a PAR. EL-1 also initially reported they had a

*Photo 1. Illustrates the front door (side-A) and the burglar bars restricting entry. Note that this security measure was on every access door and window of the structure*

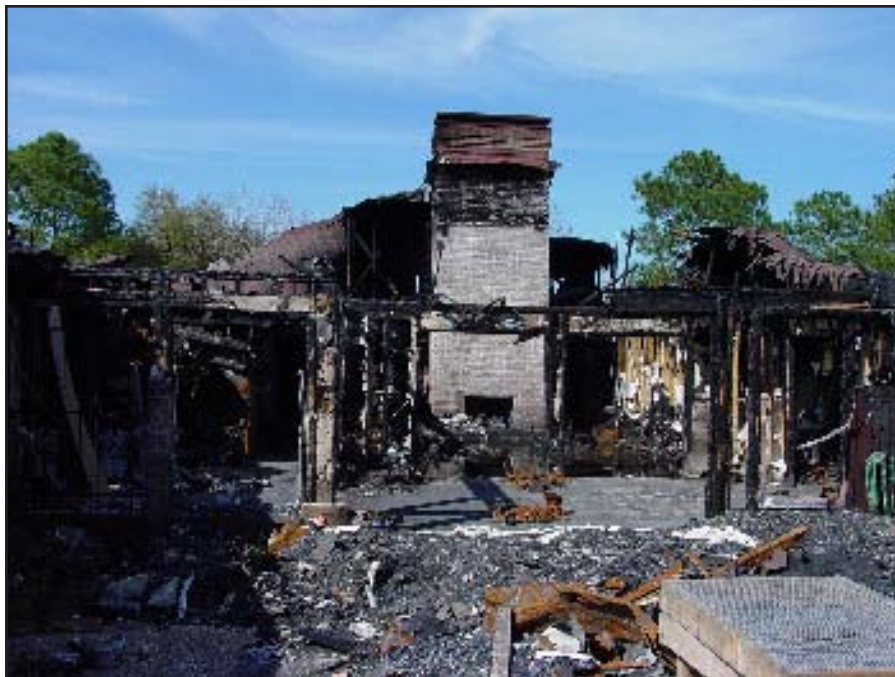
up to the chimney (Photo 2). The victim's SCBA face piece was in place. His gear and SCBA was badly damaged by the heat of the fire, and it was noted by rescuers that the PASS device was not sounding.

*Photo 2. Depicts the rear (side-C) of the structure. Note the collapse area included the majority of the structure, including around the chimney near where the victim was found.*

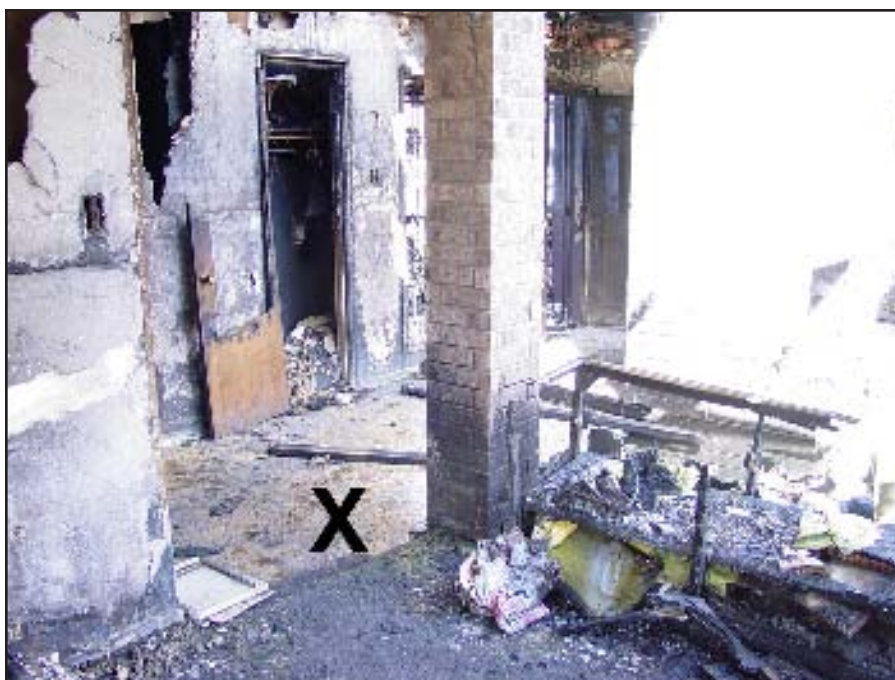
advanced through the approximate 4’ space between the wall and a brick pillar (photo 3 and diagram 3), where the victim was found.

*Photo 3. This photo shows (X) where the victim was found, facing toward the door. There was an approximate 4 foot distance between the brick column on the right and the corner of the wall on the left. This photo was taken from the interior of the house, looking toward the front door.*

***Recommendation #8: Fire departments should ensure that hose lines are not pulled from the burning structure when it is possible that a missing firefighter is in the structure.***

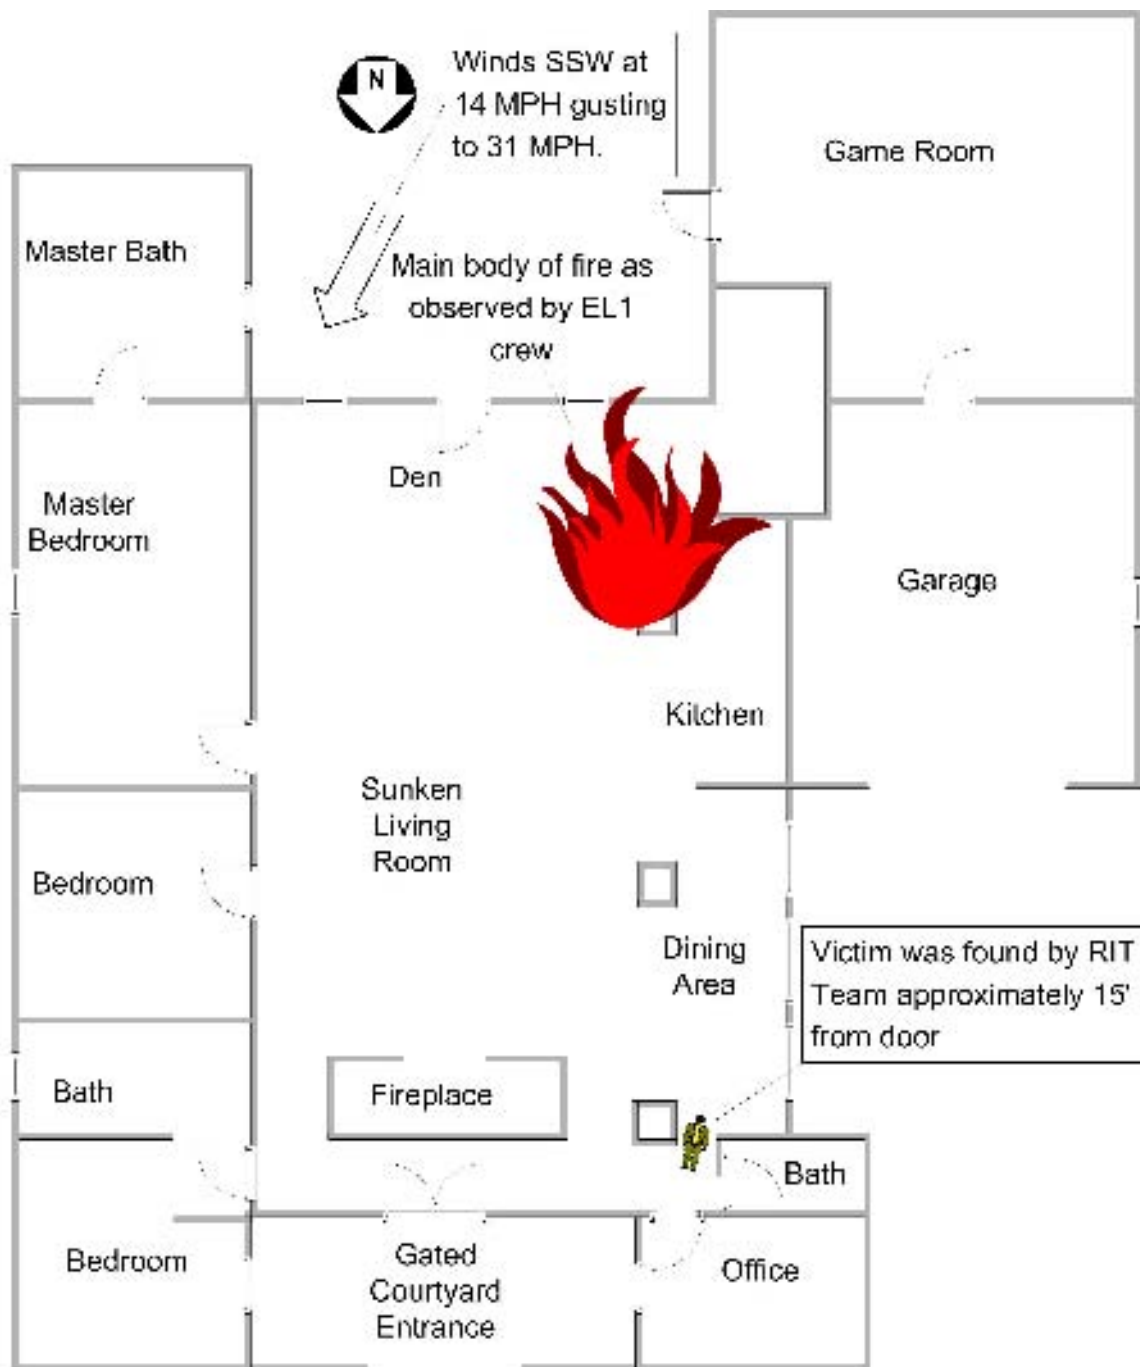
Meanwhile, due to congestion (6 firefighters) immediately inside the door, the E-5 crew staged at the entranceway on side-A. When the EL-1 and E-2 crews made entry, they came into contact with the back of the brick fireplace (Diagram 1) directly in front of and approximately 4 feet inside the front entrance of the structure. The crews (2 Lt's and 4 firefighters) both turned to the right of the fireplace to enter the structure, and began searching for the seat of the fire. Members from E-2 were operating a thermal imaging camera (TIC) in the immediate vicinity of the EL-1 crew / hand line. It was stated by the Lt. from EL-1 that he thought that the victim might have stayed at the front door to feed hose. The Lt. and firefighter from EL-1 (nozzle-man) advanced the line, and the nozzle-man reportedly hit a window with a stream at the west end of the house, which broke out. The EL-1 Lt. and the nozzle-man then advanced the hose line further into the structure, and the nozzle-man told his Lt. that it was too hot, and that his hands were "burning up". The EL-1 Lt. told him to hit the area to the left at ceiling level, which was done and the fire blackened down. The EL-1 Lt. then told the nozzle-man that the fire was also to the right. The hand line was opened again for a longer burst, then it was shut down again. It was at this point that the nozzle-man was forced to set down the hand line, handing the nozzle to the EL-1 Lt., and stating that he was too hot. The Lt. from EL-1 stated that fire immediately began rolling down to about

In this incident, a total of six firefighters (and a charged 1 – ¾ inch handline) simultaneously entered the structure through the same door - three firefighters from EL-1 and three firefighters from E-2. The access point and area where firefighters operated in this structure was not conducive to six firefighters operating, in that it was a small area. (Diagram 1).

*Diagram 1. Depicts the overall floor plan of the structure, and where the victim was located*

***Recommendation #10: Fire departments should instruct firefighters to not overcrowd the area of the interior attack team.***

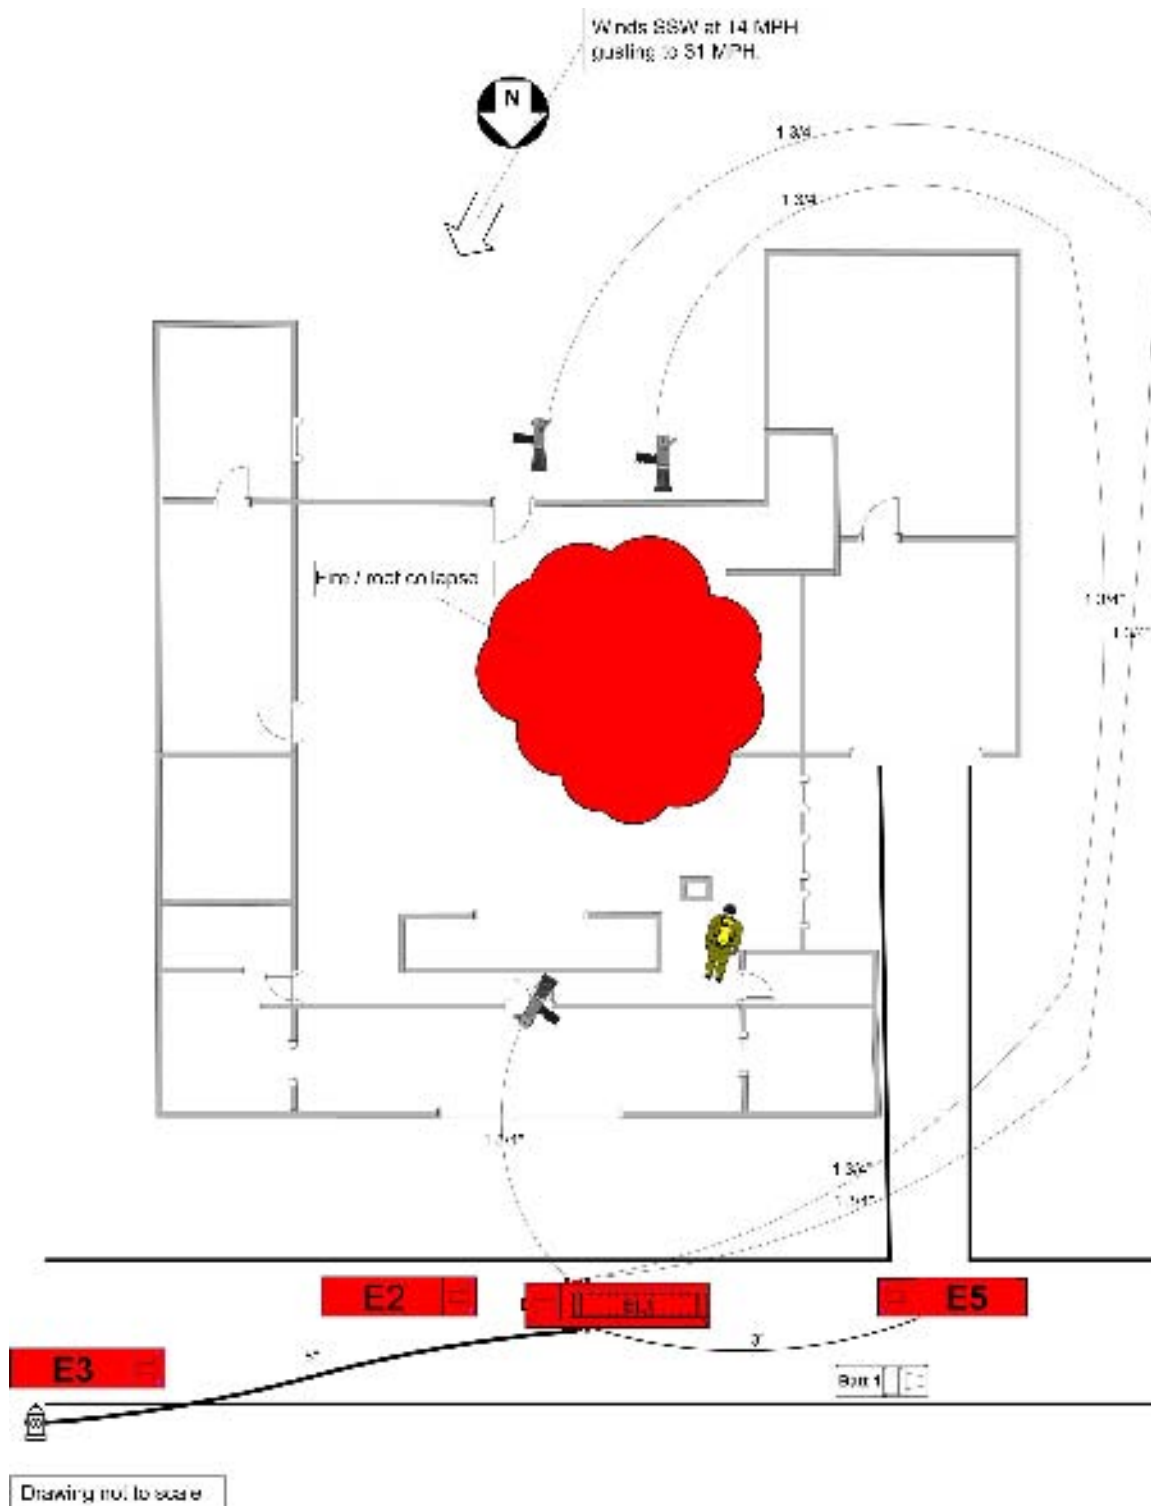
*Diagram 2. Depicts use of fire streams throughout the entire incident*

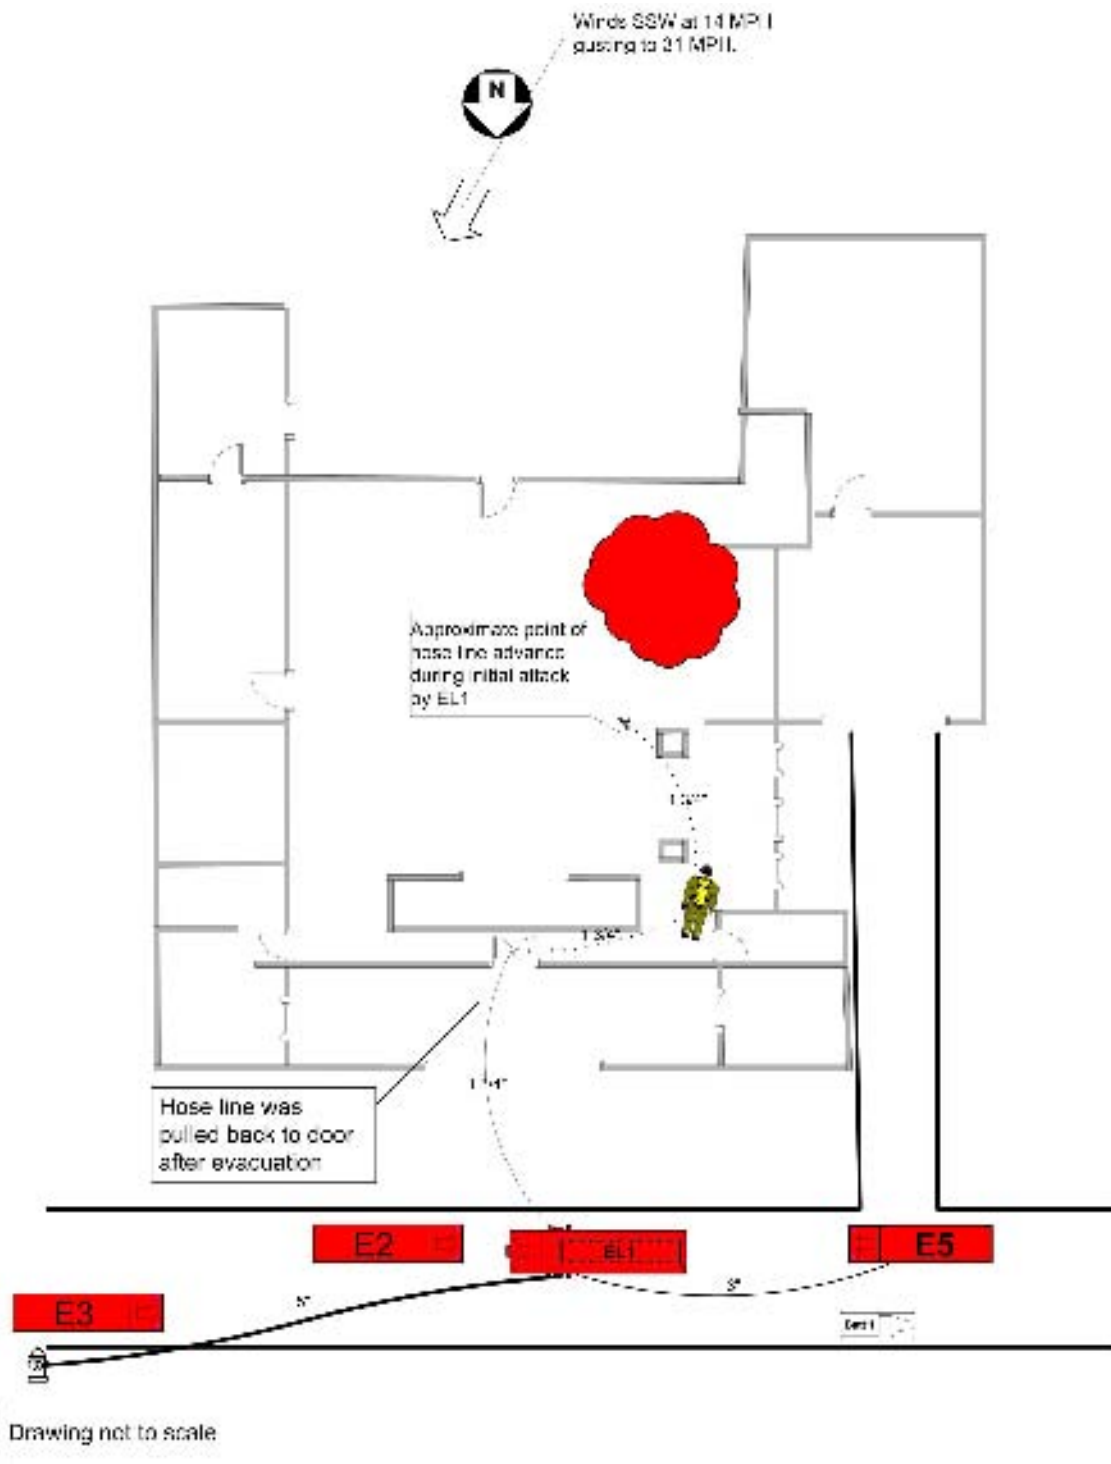
*Diagram 3. Depicts the initial hose-line advance. Note the dotted line.*
